REC-ERC-82-2

INSTALLATION OF FLEXIBLE MEMBRANE LINING IN MT. ELBERT FOREBAY RESERVOIR

September 1981

**U.S. Department of the Interior
Bureau of Reclamation**

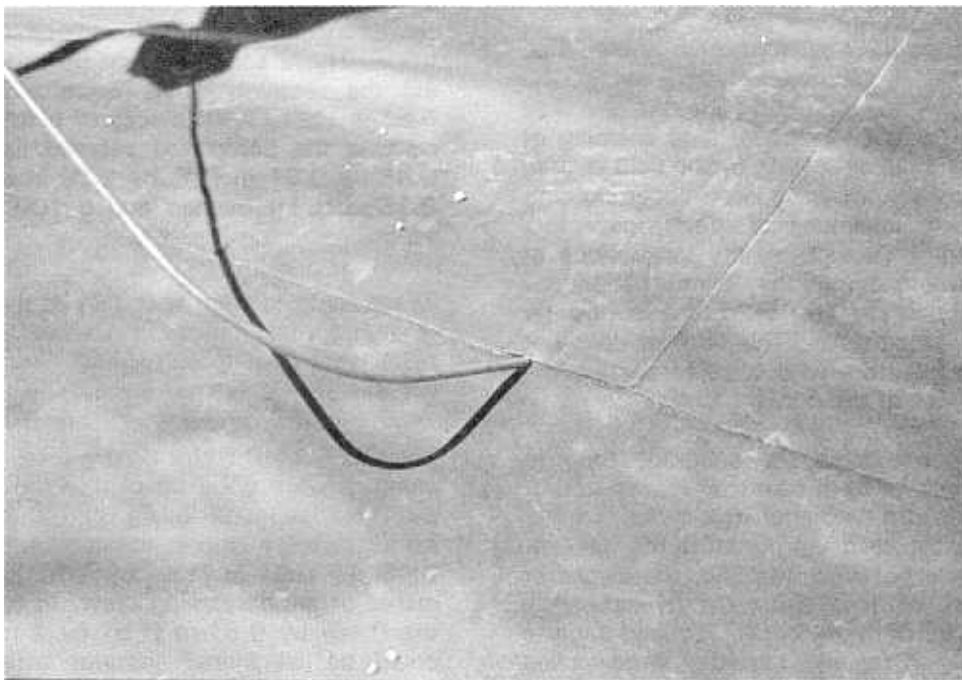
Figure 31.— Air test showing defective, unbonded section of overlap seam. Photo P-801-D-79747

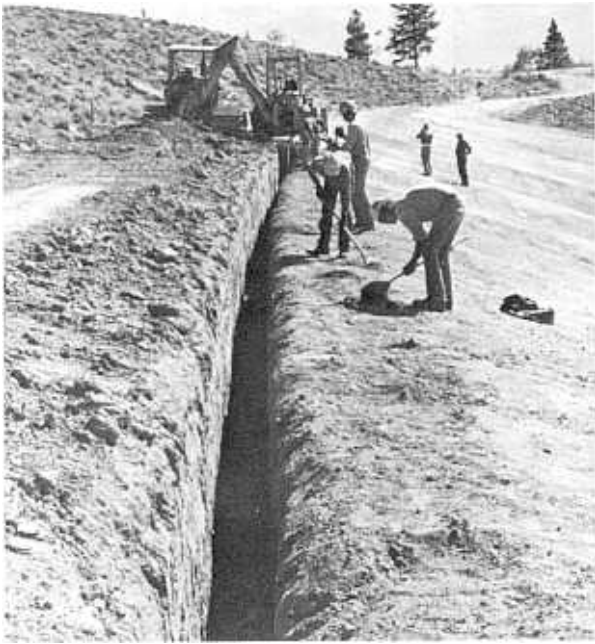
Figure 32.—Excavation of anchor trench by backhoe at top of reservoir side slope. Uncompacted area on the reservoir side of the trench was the source of the plus 25-mm (1-in) material which got under the membrane and had to be removed by cutting and patching the membrane. Photo P-382-706-28158 NA

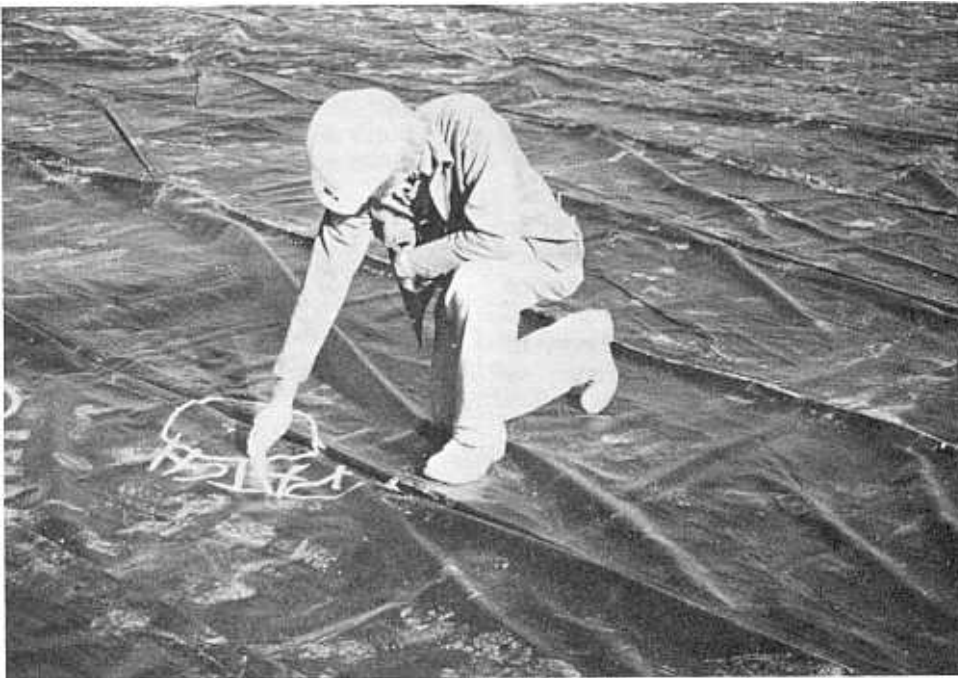
Figure 38.—USBR inspector marking defective area on membrane lining for repair. Photo P-801-D-79759

examined for any defects or punctures that required patching (fig. 38). The seaming of the blankets was monitored closely to ensure that the minimum 100-mm (4-in) wide seam was produced. After the field seams were completed and allowed to cure, they were air tested. Any defective or unbonded areas were marked and repaired prior to application of the cap strip. The air lance test was invaluable and should be specified for all jobs involving similar lining materials.

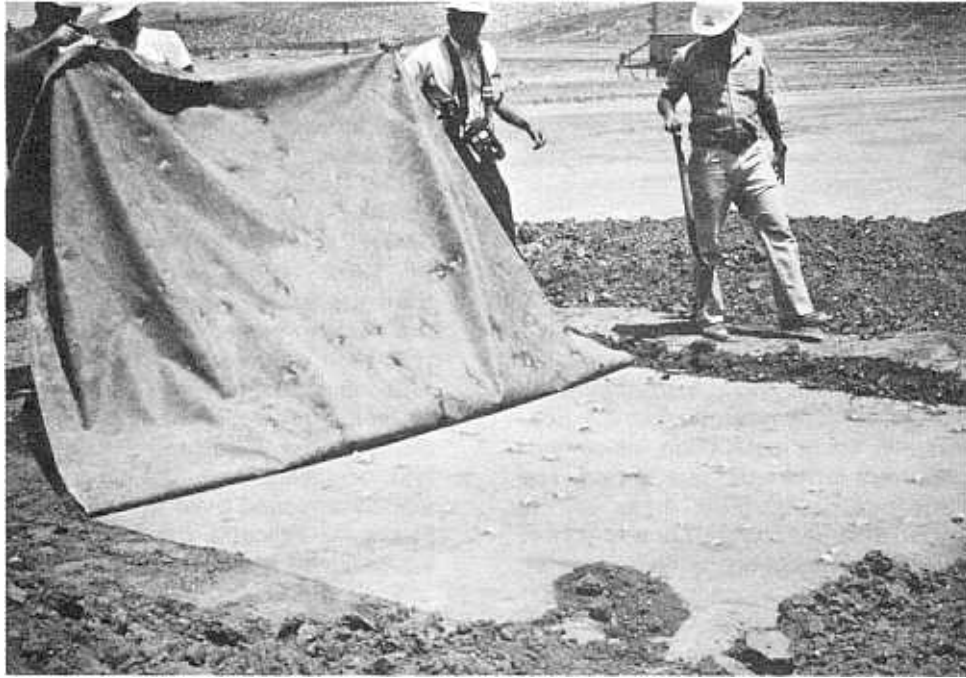
Figure 40. — Inspection of lining test section to determine effect of loose aggregate on membrane lining. Photo P-801-D-79751

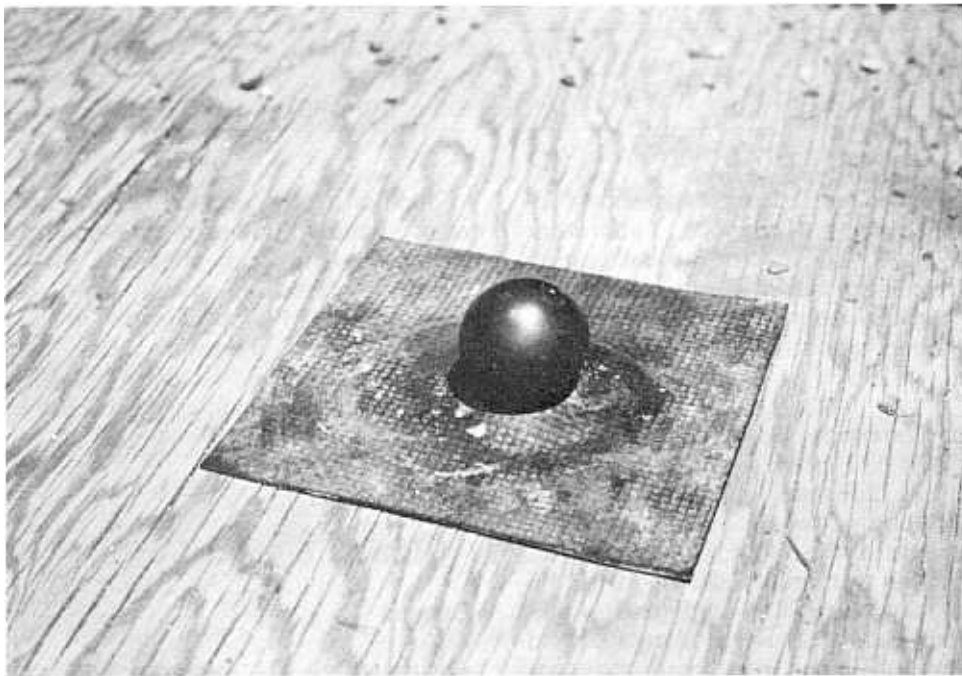
Table 2 gives the results of the Mullen hydrostatic testing of stressed versus unstressed areas of the CPER lining. As indicated, the aggregate-distressed areas generally showed a reduction in hydrostatic resistance. Of particular note are the statistical mean, standard deviation, and range which indicate an obvious deterioration in hydrostatic resistance with the mean of the distressed specimens being 689 kPa (100 lb/in²) less than the unstressed specimens.

Six of the stressed specimens failed (fig. 43), where one side of the CPE laminate ballooned because of delamination occurring at the stressed area. Varying degrees of delamination was evident in all of the aggregate-distressed specimens and showed a weakening of the scrim/CPE laminated bond. This reaction to overburden pressure was suspected because of the low elongation property of supported membranes and results of hydrostatic pressure cell testing of 1.14-mm (45-mil) CPER over a 15- to 19.0-mm (3/8- to 3/4-in) subgrade which is discussed

Figure 43.—Test specimen after Mullen hydrostatic testing. Delamination of lining has occurred due to aggregate point stressing. Photo P-801-D-79754

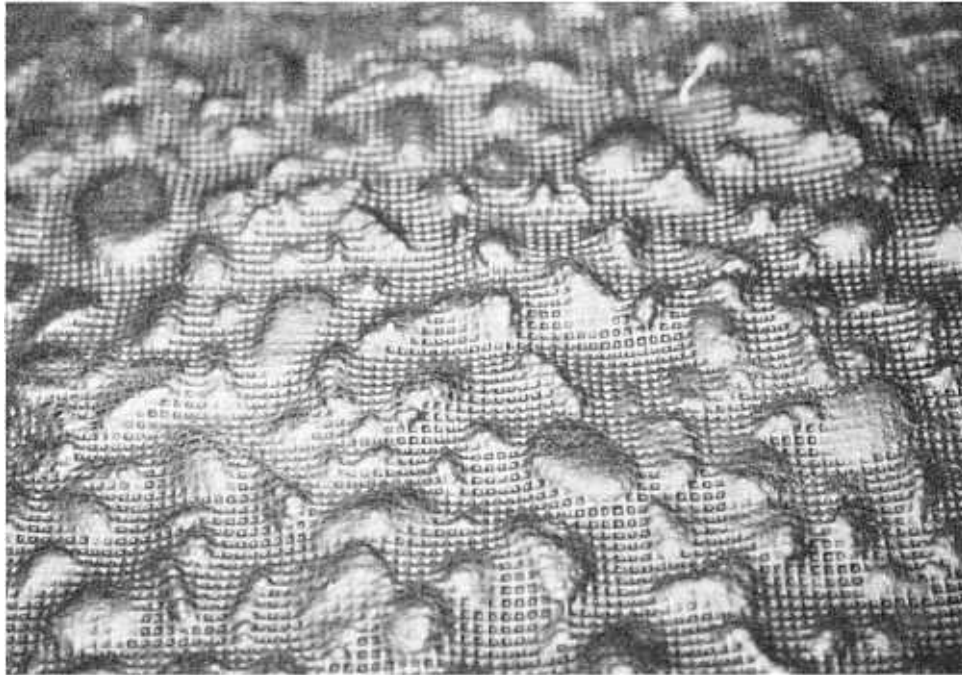
Although the membrane did not fail after 30 days at 414 kPa (60 lb/in²) (43 m (140 ft) of head), there was noticeable distress over the larger aggregate and within the voids. In particular, it was noted that the scrim fibers tended to separate within the membrane, allowing the CPE to creep and form over the aggregate. Additionally, the individual fibers were elongated and weakened. These findings reinforced the concern for proper smooth subgrade preparation and elimination of all loose surface aggregate over 12.5 mm (½ in) in size.

Figure 47.—Resultant deformation of CPER after testing over an aggregate subgrade in the hydrostatic vessels. Photo P-801-D-79757
